ELIOS 2 IN ACTION | REFINERY INSPECTIONS

LARGEST ENERGY COMPANY IN TURKEY TESTS ELIOS 2 AT REFINERY

USING THE ELIOS 2 FOR AN FCC UNIT INSPECTION ALLOWED OIL & GAS REFINING COMPANY TÜPRAŞ TO AVOID SENDING AN INSPECTOR INSIDE A REACTOR RISER, KEEPING THE INSPECTOR OUT OF A POTENTIALLY DANGEROUS SITUATION AND SAVING THE COMPANY TIME AND MONEY.

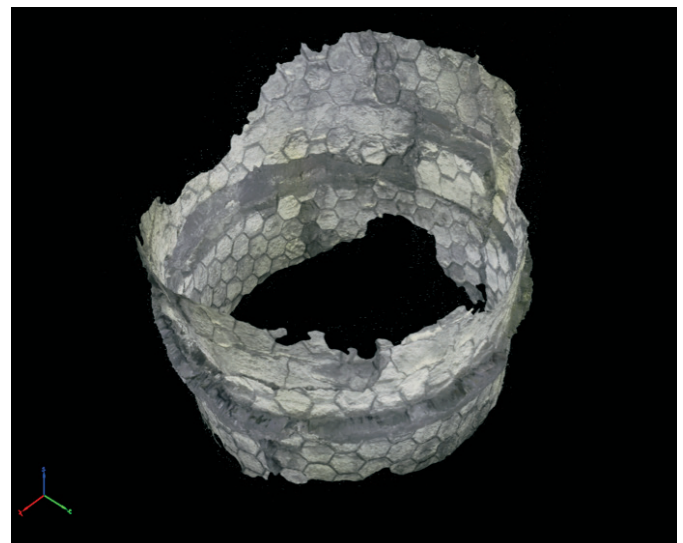
- **A general inspection flight** to the top of the riser and back down to collect visual data on the state of the entire pipe. After conducting this flight the video footage was analyzed frame by frame by the Tüpraş inspection team. The analysis revealed a potentially damaged section of the riser.

- **A detailed inspection flight** was made to further inspect the potentially damaged area revealed by the general inspection flight so that a maintenance decision could be reached. The Elios 2 was taken back to the site of the damage and then locked in place using the drone's unique distance lock. Visual footage was collected for a 360-degree view of the damaged section of the pipe. This footage was then reviewed by Tüpraş inspectors and they decided that no action was needed.

3D map of the riser created with data collected by the Elios 2

A 3D model of the riser rendered from the visual data the Elios 2 collected using Pix4D modeling software was crucial in making the decision about whether action should be taken to fix the defect found on the general inspection flight.

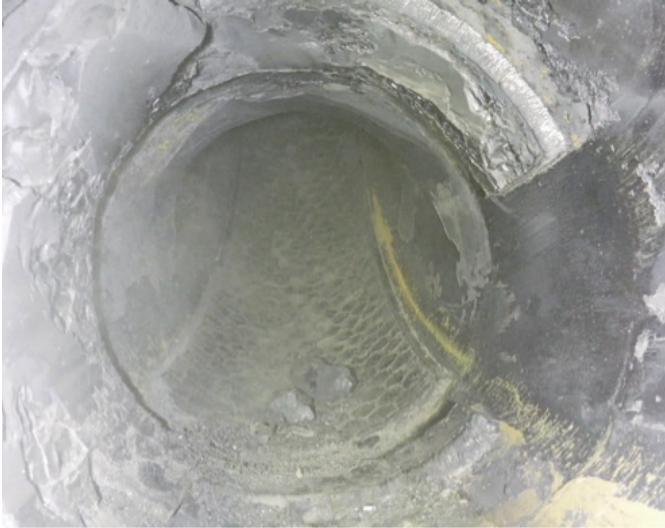
Image taken inside the vapor pipe by the Elios 2

The visual inspections of the vapor overhead pipe and of the cyclones with the Elios 2 were successful and found no major defects present.

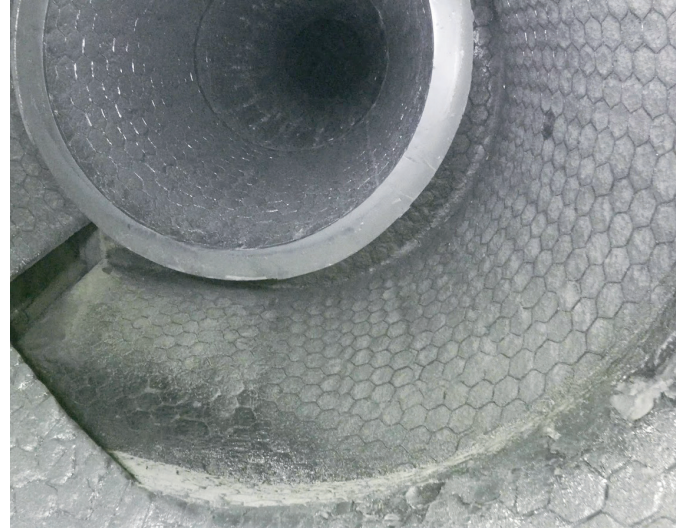
Image taken inside a cyclone by the Elios 2
